Restoring a Landmark
THE NEW YORK STATE CAPITOL

Restoring a Landmark THE NEW YORK STATE CAPITOL

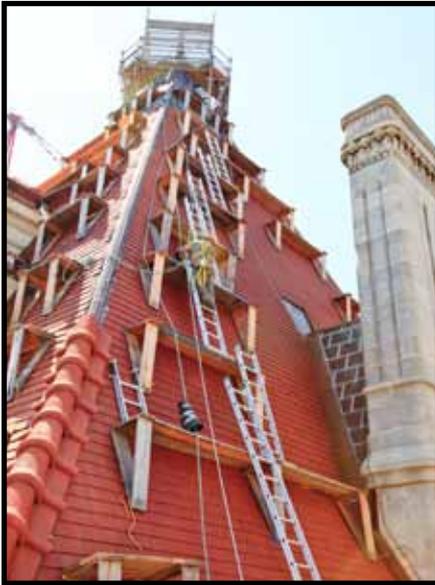
While work progressed on the Capitol's grand interior spaces, over a hundred workers labored above to repair and rehabilitate the building's roof. The project focused on the eastern half of the roof, including northeast and southeast French Renaissance-style pavilion towers. The terra cotta surfacing on each of the towers was over 120 years old and badly deteriorated due to weathering and damage from earlier repairs. Not able to salvage any of the materials, each of the old terra cotta tiles were removed and new tiles and additional custom terra cotta pieces were replicated based on their original design.

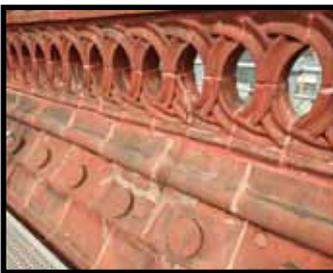
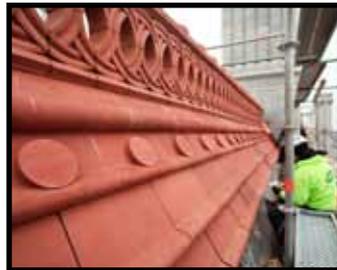
A before and after view of the decorative terra cotta entwined circular motif that embellishes the east facade ridge fence.

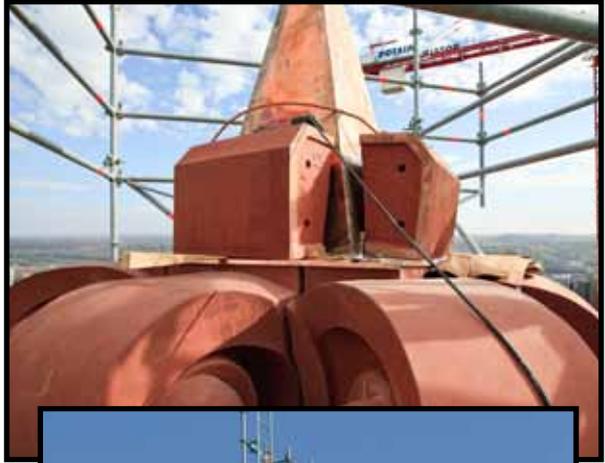
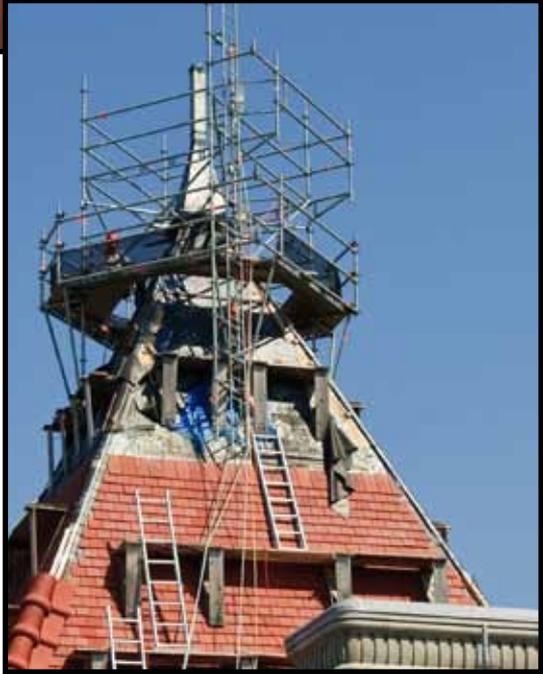
Tower Finials

Literally capping the work on the roof was the installation of an elaborate finial at the top of each pavilion tower. The design and installation of the finials was no easy task. Each finial is constructed from 105 separate terra cotta pieces, consisting of 17 courses, or rows, and measuring 28 feet high. Additionally, the Capitol's lightening arrestors - braided steel cables grounded to the steel structure of the roof - terminate at the top of each finial.

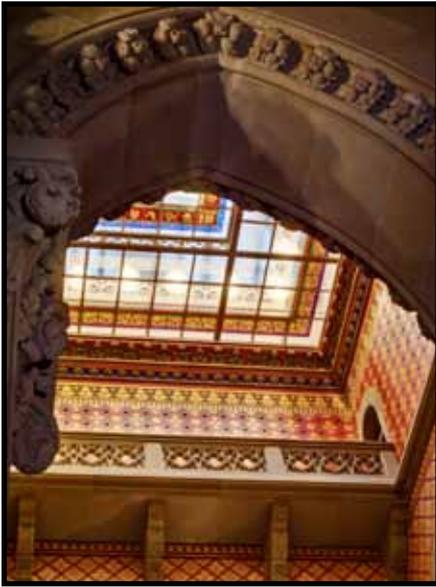
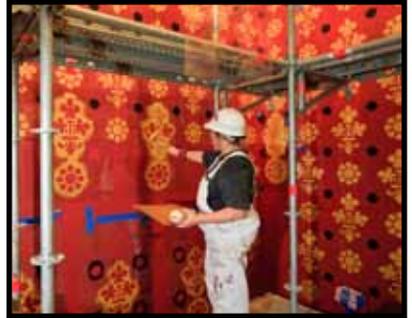
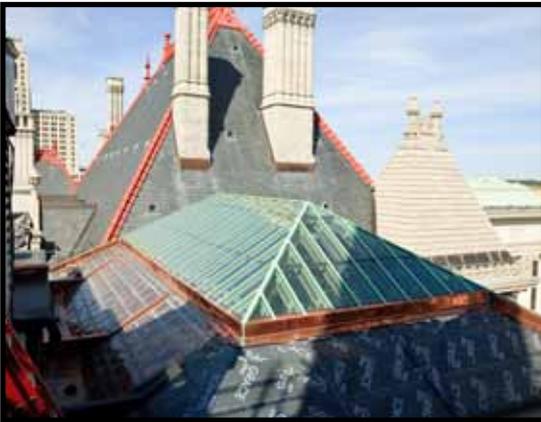
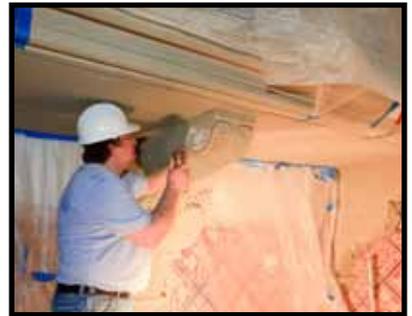
Assembly Staircase Skylight and Laylight Restoration

The 2011 restoration of the Assembly Staircase was a central part of the Capitol roof rehabilitation project. All elements of the 1940s renovations were removed, the skylight was reinstalled, the laylight reconstructed, and the staircase's upper walls and masonry repaired and repainted with precise, historic detail.

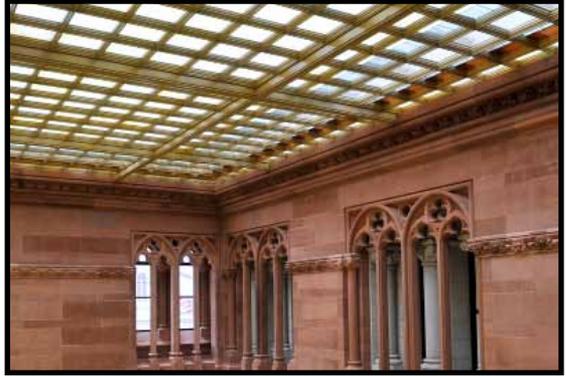
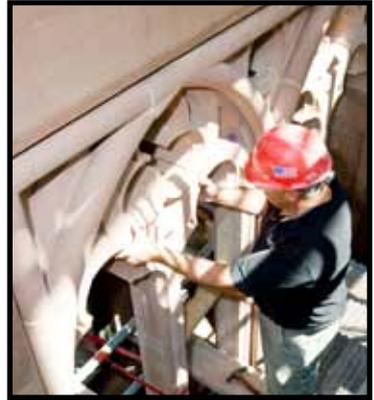
Senate Staircase Skylight and Laylight Restoration

In 1946, a need to create additional office space led to major alterations of the staircase's original design. The skylight was replaced with a plywood and copper roofing, the laylight was removed, and a new floor was inserted across the staircase at the fifth floor level, truncating the height of the staircase.

During the Senate Staircase restoration, all elements of the 1940s renovations were removed, the skylight and laylight reconstructed, and damage to the staircase's upper masonry was repaired. In January 2013, Governor Andrew M. Cuomo unveiled the Senate Staircase to the public, revealing a space returned to its monumental design. The completion of the Senate Staircase marks the end of the overall Capitol roof restoration project.

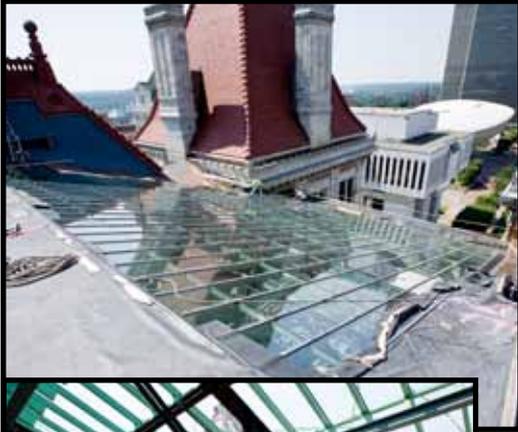
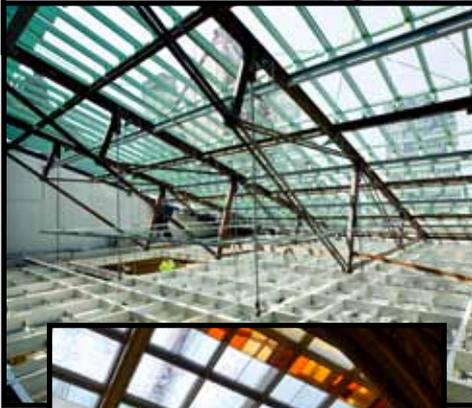
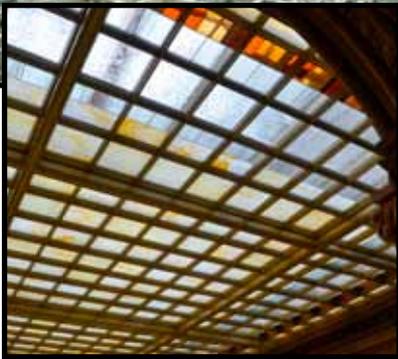
Senate Staircase Skylight and Laylight Restoration

The laylight crowning the top of the Senate Staircase is designed to diffuse the direct natural light streaming in from the skylight above. The original steel trusses supporting the skylight were left intact and used for the restoration; however, because the laylight structure was removed altogether, its design proved more

difficult to reconstruct. Using evidence left behind from the removal of the laylight in the 1940s, architects were able to determine the exact measurements of the laylight's grid framing. Unfortunately, there are no known images of the original laylight and few clues were found regarding the color and patterning of the glass itself. Unable to produce an exact replication of the laylight, the architects designed the new laylight to be a contemporary interpretation deferential to the significant historic quality of the staircase.

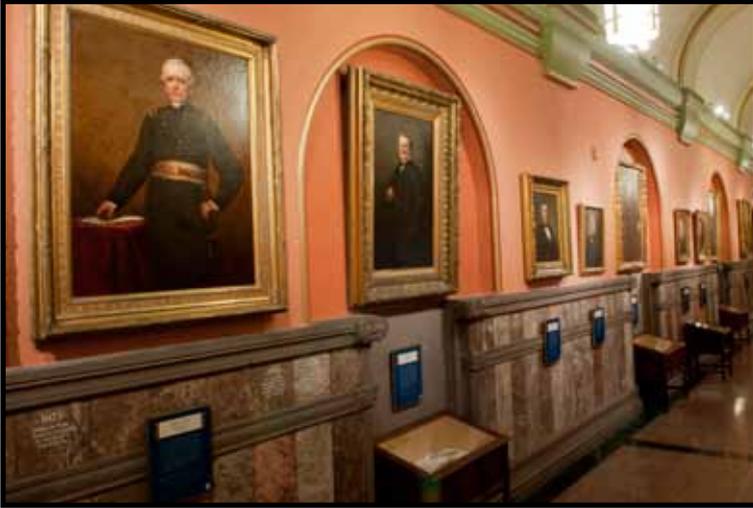
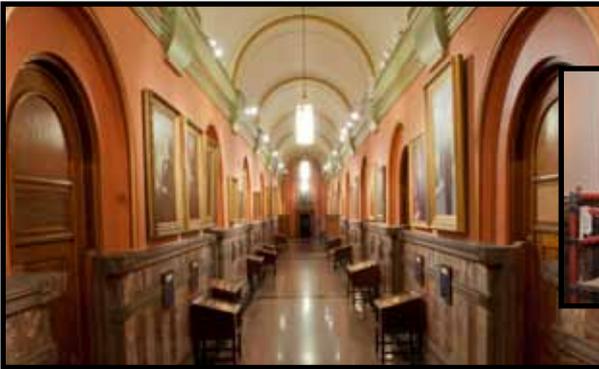
The Hall of Governors

The Hall of Governors' dramatic renovation included cleaning the stonework, and repairing, replastering, and repainting the walls. In addition, a state-of-the-art lighting system was installed to draw focus on the state's collection of historic portraits of New York State governors.

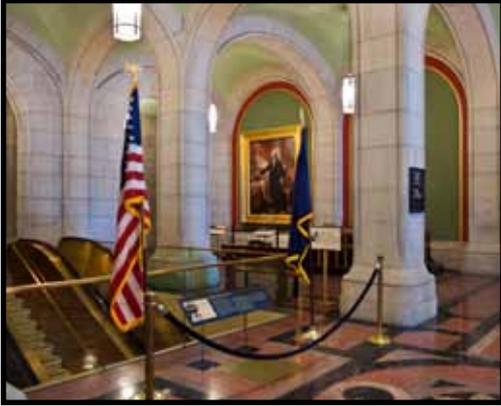
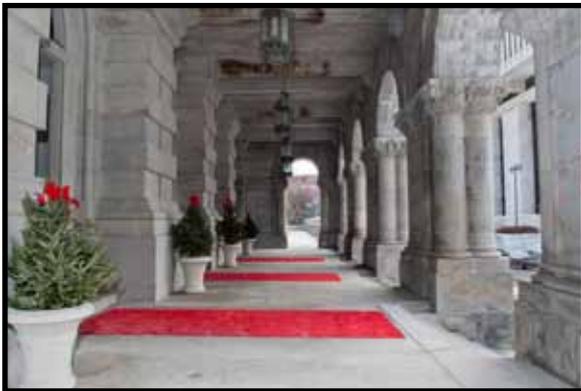
Cleaning House

A walk in and around the New York State Capitol today is a much brighter experience thanks to the personal interest Governor Andrew M. Cuomo took in sprucing up the building's interior. In the fall of 2012, an intensive effort was launched to examine every surface of the Capitol and identify and implement a series of cleaning projects. Work crews labored to remove multiple layers of wax that had

built up on the marble and granite floors and baseboards over the last 40 years. They cleaned masonry and intricate stone carvings that were stained with decades-worth of emissions from coal furnaces once used to heat the Capitol, and cigarette and cigar smoke. Even brass railings and kick plates sparkle after a half-century of neglect. No detail too small, evidence of the Capitol's renaissance can be seen throughout the building.

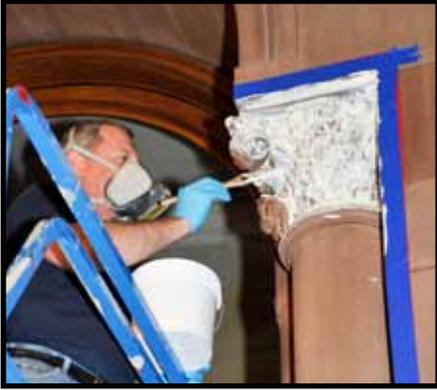
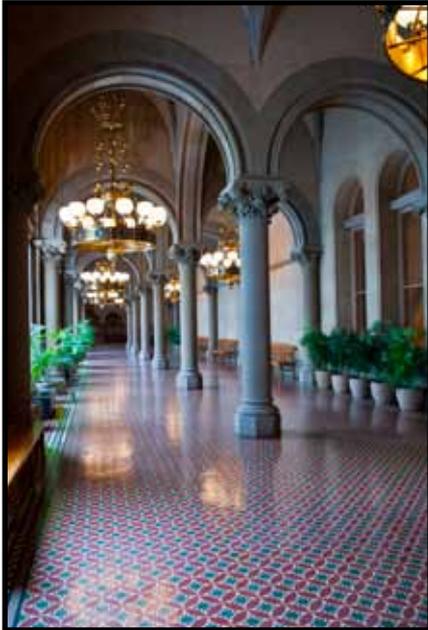
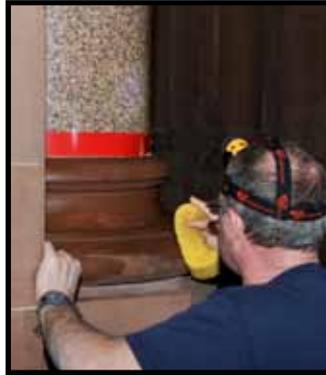
Cleaning House

The cleaning of the elaborately carved granite and sandstone arches and columns, and other decorative stonework, was a significant undertaking. A specially trained team of employees from the Office of General Services used a latex cleaning product that was applied to the stone. As the latex dried, it captured dirt from crevices in the stone and was then peeled off as an elastic film, removing the dirt with it.
